ASSESSMENT SUMMARY SHEET FOR UKAB MEETING ON 20th MARCH 2013

AIRPROX REPORT No 2012131

Date/Time: 23 Aug 2012 1354Z

Position: 5047N 00016W
(Shoreham NDB Hold)

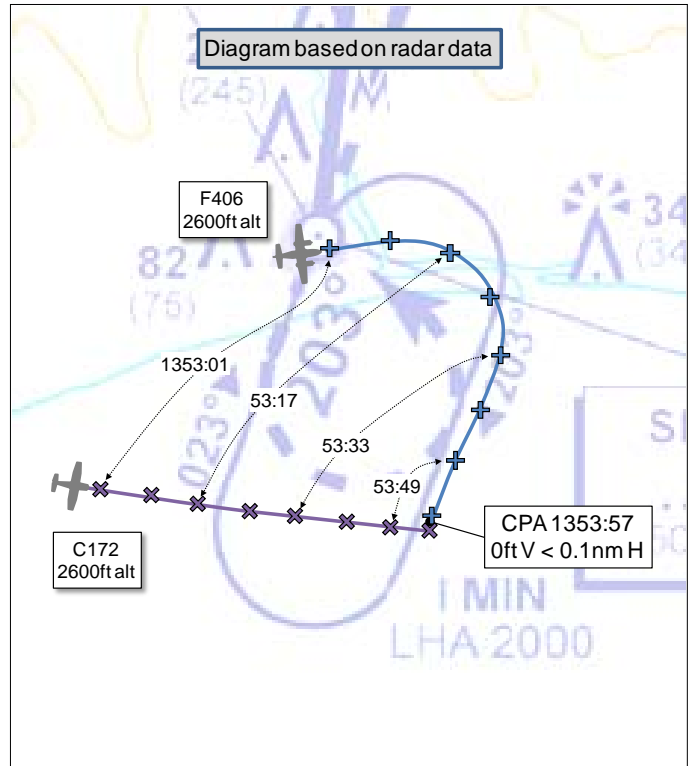
At 1353:12 the F406 pilot had crossed over the SHM NDB and was in a R turn, tracking S at 2600ft. The C172 was 2.5nm SSW of Shoreham tracking E, also at 2600ft (see Figure 1 below).

At 1353:45 the F406 was tracking SSW, joining for the NDB procedure while the C172 was tracking E, 0.9nm WSW of the F406 (see Figure 2 below).

The C172 pilot's report stated that he first saw the F406 at approximately 1000m, to the L and 100m below, climbing. The C172 pilot considered avoiding action but decided to maintain height and heading as 'anything else did not appear to be appropriate. It was up to the other pilot to avoid a collision'. The C172 pilot observed that the F406 abruptly made a R turn and crossed behind him at a distance of 100m or less.

The pilots shared equal responsibility to see and avoid and although the C172 pilot appeared to take no action, it was the late sighting by the F406 crew which caused the Airprox. The Board considered that the F406 pilot saw the C172 at about the last available opportunity and as a result had to manoeuvre aggressively to avoid it. Consequently, safety margins were reduced much below normal.

Cause: Late sighting by the F406 crew.

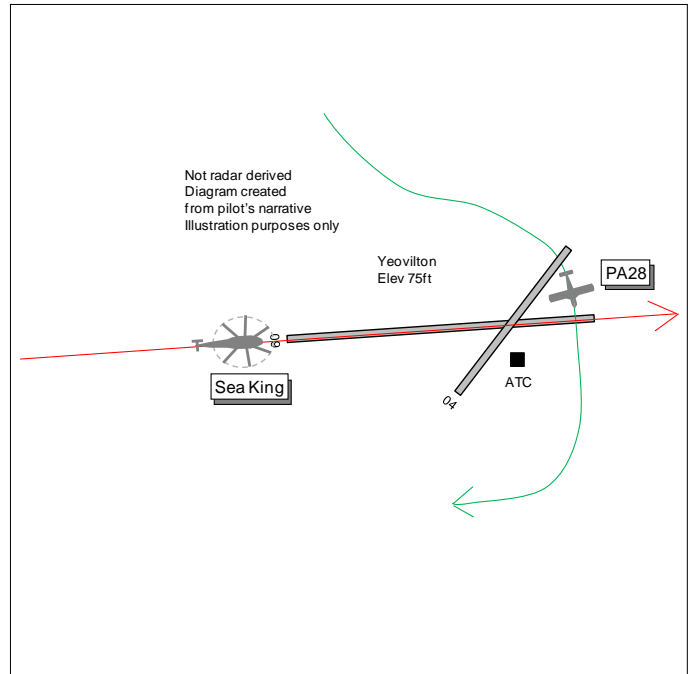
THE SEA KING PILOT reports flying a training flight using NVDs inbound from Poole HLS and in communication with Yeovilton Approach on UHF Channel 3, squawking 0222 with Modes S and C; TCAS was not fitted. The visibility was 10km flying 1000ft below cloud in VMC and the helicopter's red HISLs and flashing dim nav lights were switched on. Approaching decision height on a PAR approach and during the overshoot they saw traffic [the PA28] in their 9 o'clock to the N of their position. They initially thought the other ac may pass down their LHS and continue on its track. However, passing the RW09 midpoint approaching 1000ft QFE 994hPa heading 090° at 90kt they saw the other ac approach in a banking R turn from the N and cross the duty RW across their flightpath <500m ahead; they estimated the separation as 400m horizontally and 100ft vertically at the CPA. The ac continued its banked turn as it passed down their RHS. No avoiding action was taken as they were visual with the ac throughout. They had not heard the traffic on the Tower frequency or permission for the traffic to cross the duty RW. He assessed the risk as medium. Clearly the time for the ac to pass from L to R was a matter of seconds and had their helicopter been slightly higher or R of track and not visual with it then there would have been a high risk of collision.

The initial factor which started the evolution to the Airprox was the disconnect between the YAvOs and the YFC FOB. The PA28 pilot was expecting to carry out an O/H join iaw YFC FOB; however, this procedure was not permitted in the YAvOs. Nevertheless, this request by the PA28 pilot, instead of being refused by the APP, was approved. The APP then did not apply positive control to the PA28 flight by issuing instructions to ensure both ac were deconflicted. This resulted in the PA28 flying into conflict with the Sea King on a go-around, which was the cause of the Airprox.

Cause: The Yeovilton APP allowed the PA28 flight to carry out an O/H join, contrary to YAvOs, and fly into conflict with the Sea King on a go-around from PAR.

Five recommendations were made: -

2) Recognition of unusual situation during low arousal. The progression of events from the approval of the PA28 pilot's request for an O/H join, to the point where the PA28 crossed the path of the overshooting helicopter, resulted from lack of SA by the ADC. Although visual with the PA28, clearly no contact had been established and this should have been questioned in a more robust manner as the situation developed. All controllers should be rebriefed on taking appropriate actions in the event of recognising an unusual circumstance that could lead to an unsafe situation developing, particularly during periods of low arousal such as during night flying. Action completed 10/12/2012. The results of the originating report have been highlighted to all ATC staff through formal training briefs (conducted 3 x weekly) and informally through Watch Leaders. Other ATC Incident reports have been promulgated for wider awareness and this has included populating the ATC crewroom with Accident/UKAB reports.

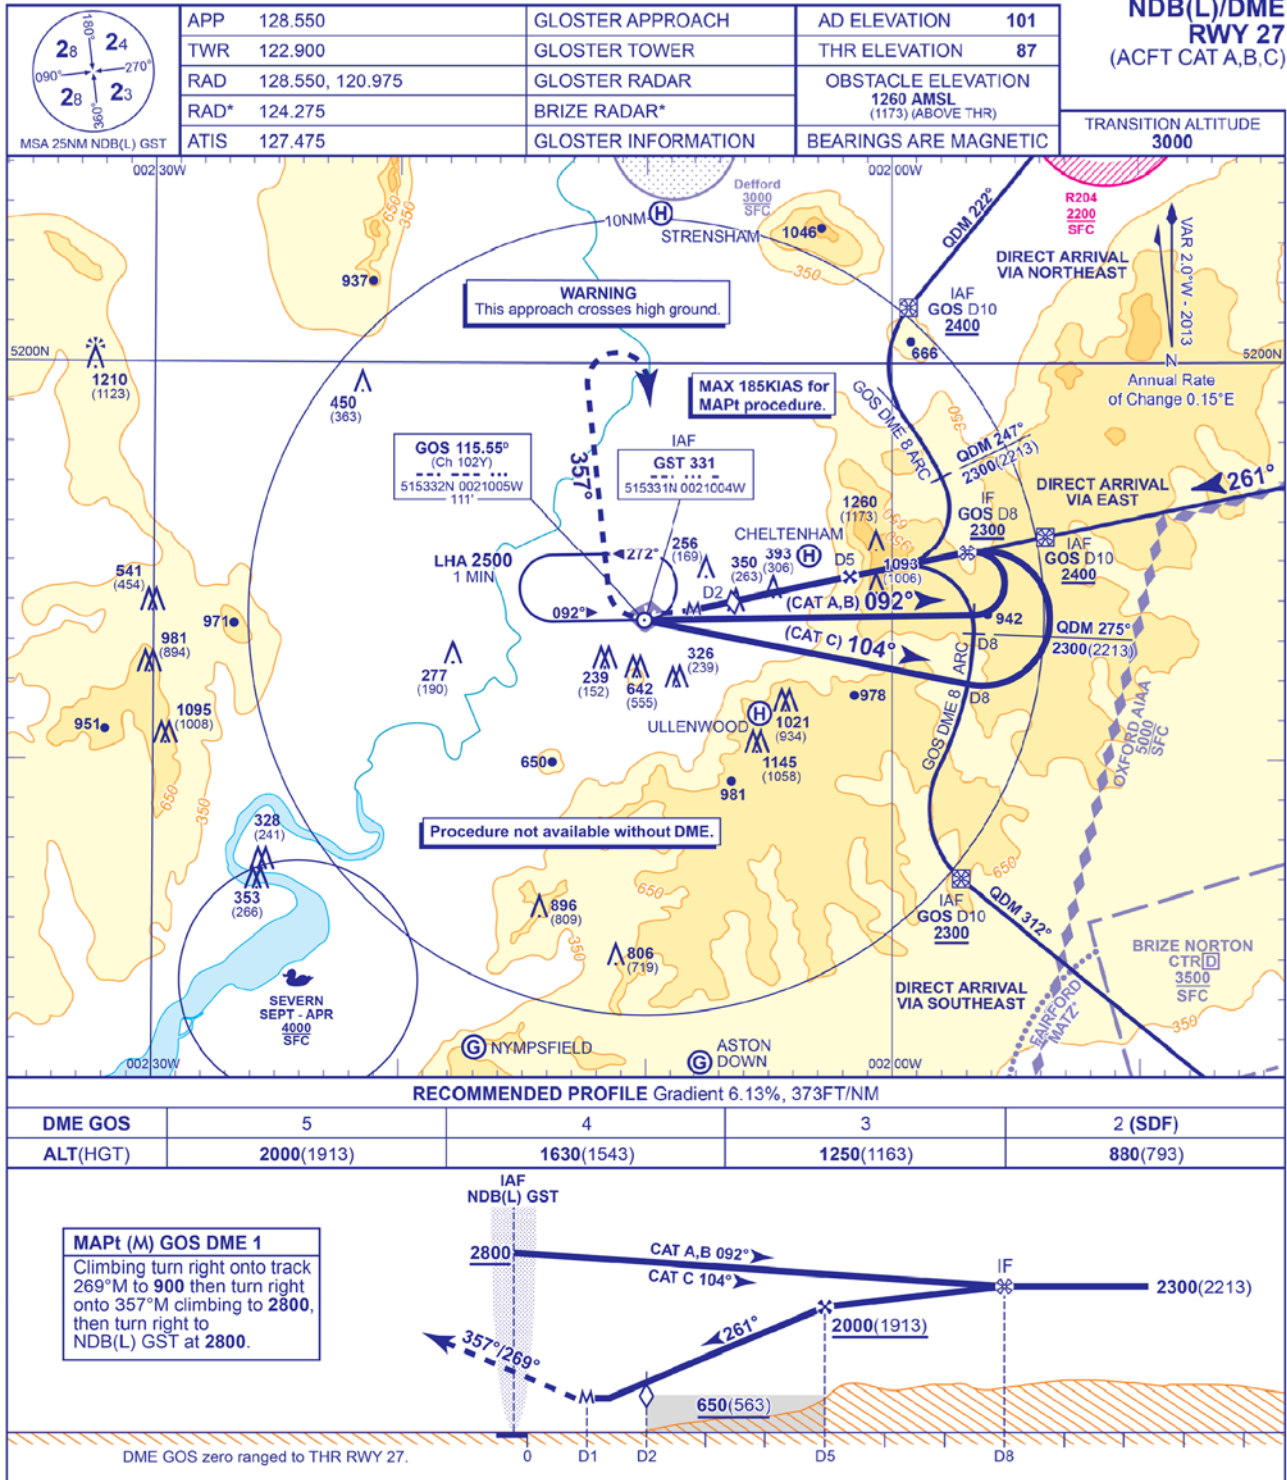
Fig (1)

The missed approach procedure for the NDB(L)/DME RW27 approach is promulgated in the UK AIP AD 2-EGBJ-8-6 as: ‘Climbing right turn onto a track 270°M to 900 then turn right onto 359°M climbing to 2800, then turn right to NDB(L) GST at 2800’. The hold is a 1min LH racetrack inbound QDR 092°. (See Fig 1 below)

At 1056:50, the radar recording shows the BE35 in the missed approach procedure 6-8nm N of the airfield in a non-standard L turn passing FL034 in the climb. The SR22 is approaching the GST on W'ly heading at FL042.

Cause: The BE35 pilot did not follow the standard Missed Approach Procedure and climbed into conflict with the SR22.

The ATSU has recommended that as part of unit best practice controllers should, at an appropriate point, include the reiteration of the missed approach level, together with appropriate TI. Since the Airprox, controllers have been made aware of the requirement and the unit MATS Part 2 will reflect these changes at the next update due February 2013.

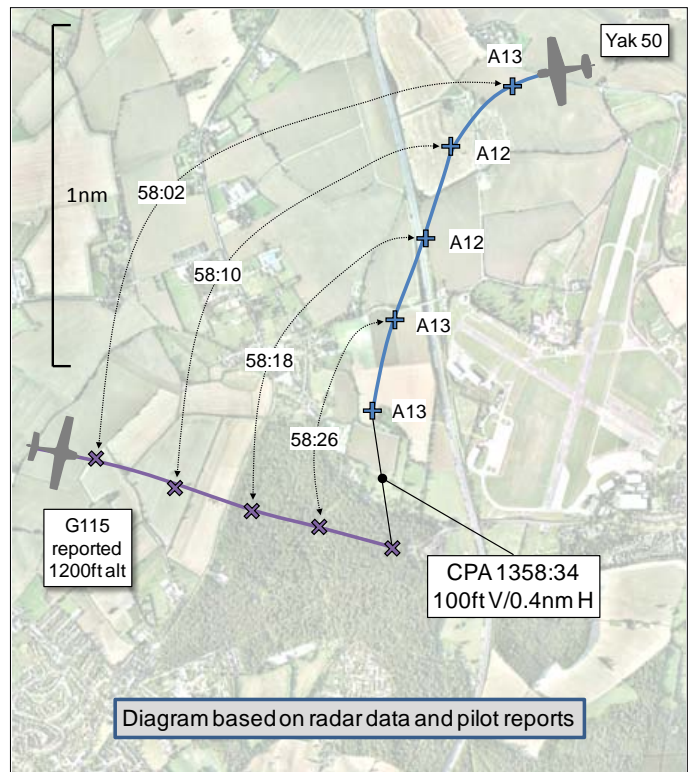
At 1358:00 the Yak 50 pilot advised North Weald Radio of his intention to simulate an engine failure and to overfly the A/D without undercarriage. At 1358:25 the Yak 50 was shown midpoint downwind, indicating 1300ft, with the Grob 115 in the Yak 50 pilot’s 12 o’clock at a range of 0.5nm, crossing from R to L towards the RW02 threshold. The Yak 50 pilot reported traffic ‘just going crosswind’. The A/G operator replied that the other traffic had not identified itself to North Weald. The Grob 115 pilot’s written report indicated being visual with the Yak 50 at approximately the same level.

At 1359:03, the Yak 50 pilot cancelled the simulated engine failure and reported heading E to ‘come back in a few minutes’. Radar recording showed the Yak 50 pilot turning towards the Grob 115 at a range of 0.9nm. The Yak 50 is shown to follow the Grob 115 on an E’ly track at 1000ft. The Yak 50 pilot continued to follow and manoeuvred behind the Grob 115. At 1401:48, the Yak 50 was shown 0.1nm NW of the Grob 115 at 900ft. The Yak 50 pilot continued to fly parallel to the Grob 115 and at 1402:00 was shown in the Grob 115 pilot’s 3 o’clock position at 0.1nm. The two ac continued converging and, at 1402:06, the distance between them reduced to less than 0.1nm. At 1402:14 the radar contacts merge with the Yak 50 indicating 800ft. The Grob 115 pilot’s written report indicated his being surprised to see the Yak 50 in close formation, within 10-15m of his ac for 20sec before breaking away behind and below.

Cause: The Yak 50 pilot was concerned by the proximity of the Grob 115 in the vicinity of the North Weald circuit.

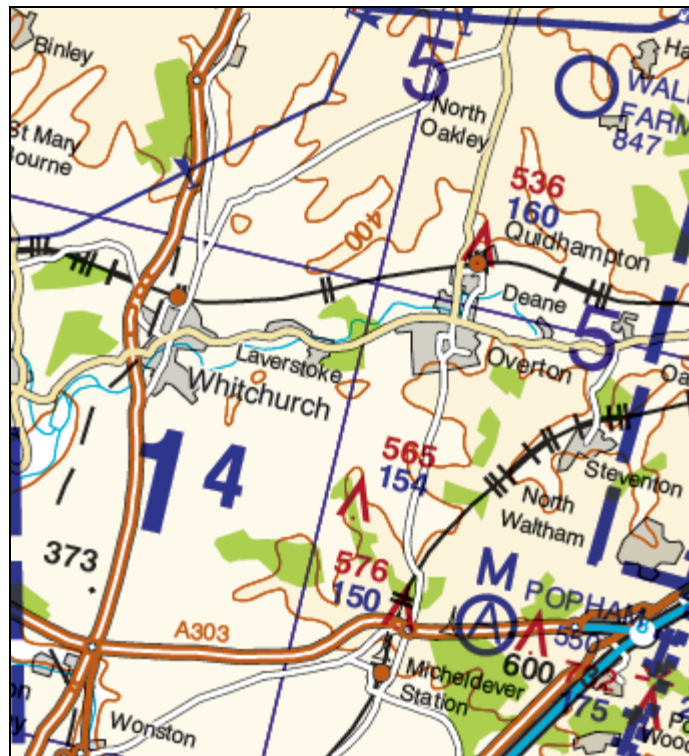
Figure 1: Extract from LF Chart Depicting Area of Airprox.

BM SAFETY POLICY AND ASSURANCE reports that the Airprox occurred at 120ft agl, between Whitchurch and Overton within LFA1 and just E of the A34, approximately 13nm W of Odiham (Figure 1 refers, the W edge of Odiham's MATZ stub can be seen to the right of the picture), between a Merlin in receipt of a BS from Odiham Information and a pair of Squirrels.

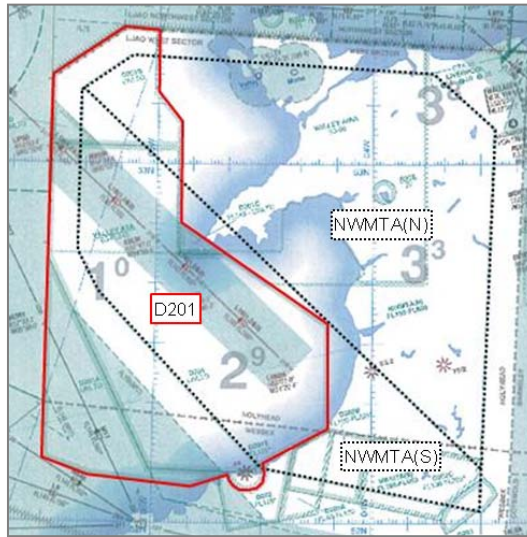
Figure 1: Depiction of NWMTA and D201

The Mil AIP, ENR 5-2-18 Para 9.1, states that the NWMTA has 'been established within Class C airspace to provide military ac with the operational freedom to manoeuvre, without the requirement for the provision of a RCS. Although the airspace is intended for autonomous activity, a DS, TS or BS may be requested from the military ATCC'. The vertical boundaries of the NWMTA are FL195-FL660 (see Figure 1). The RAF Valley FOB states that deconfliction between 4FTS traffic within the NWMTA but outside of the VATAs 'is to be achieved by either requesting a TS or DS or by free-calling the [4FTS] deconfliction frequency'.

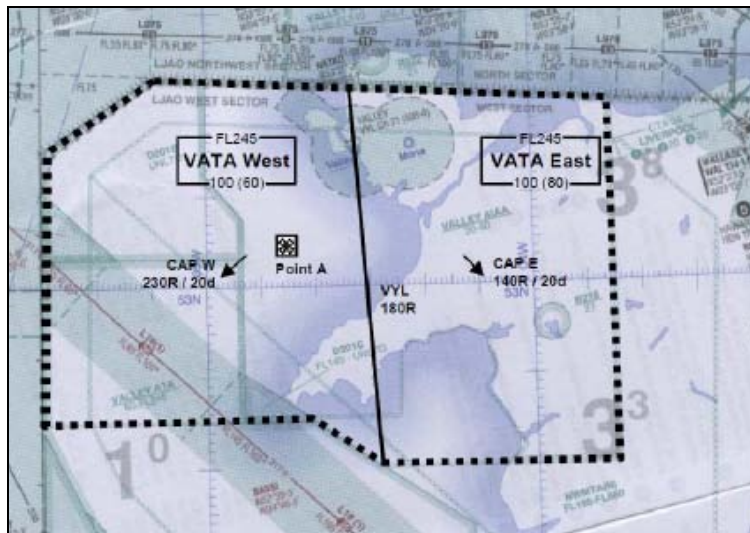
Figure 2: Depiction of VATAs

‘the northern part of the NWMTA is divided into 2 areas by the VYL 180° radial: VATA East and VATA West (see Figure 2). The VATAs provide a degree of autonomy from other 4FTS users and may be activated by formations conducting Air Defence training or other high energy manoeuvring. However, aircrew should be aware that the VATAs are a local arrangement only and sit within Class G airspace and that other, non-4FTS traffic, may be encountered within them.’
